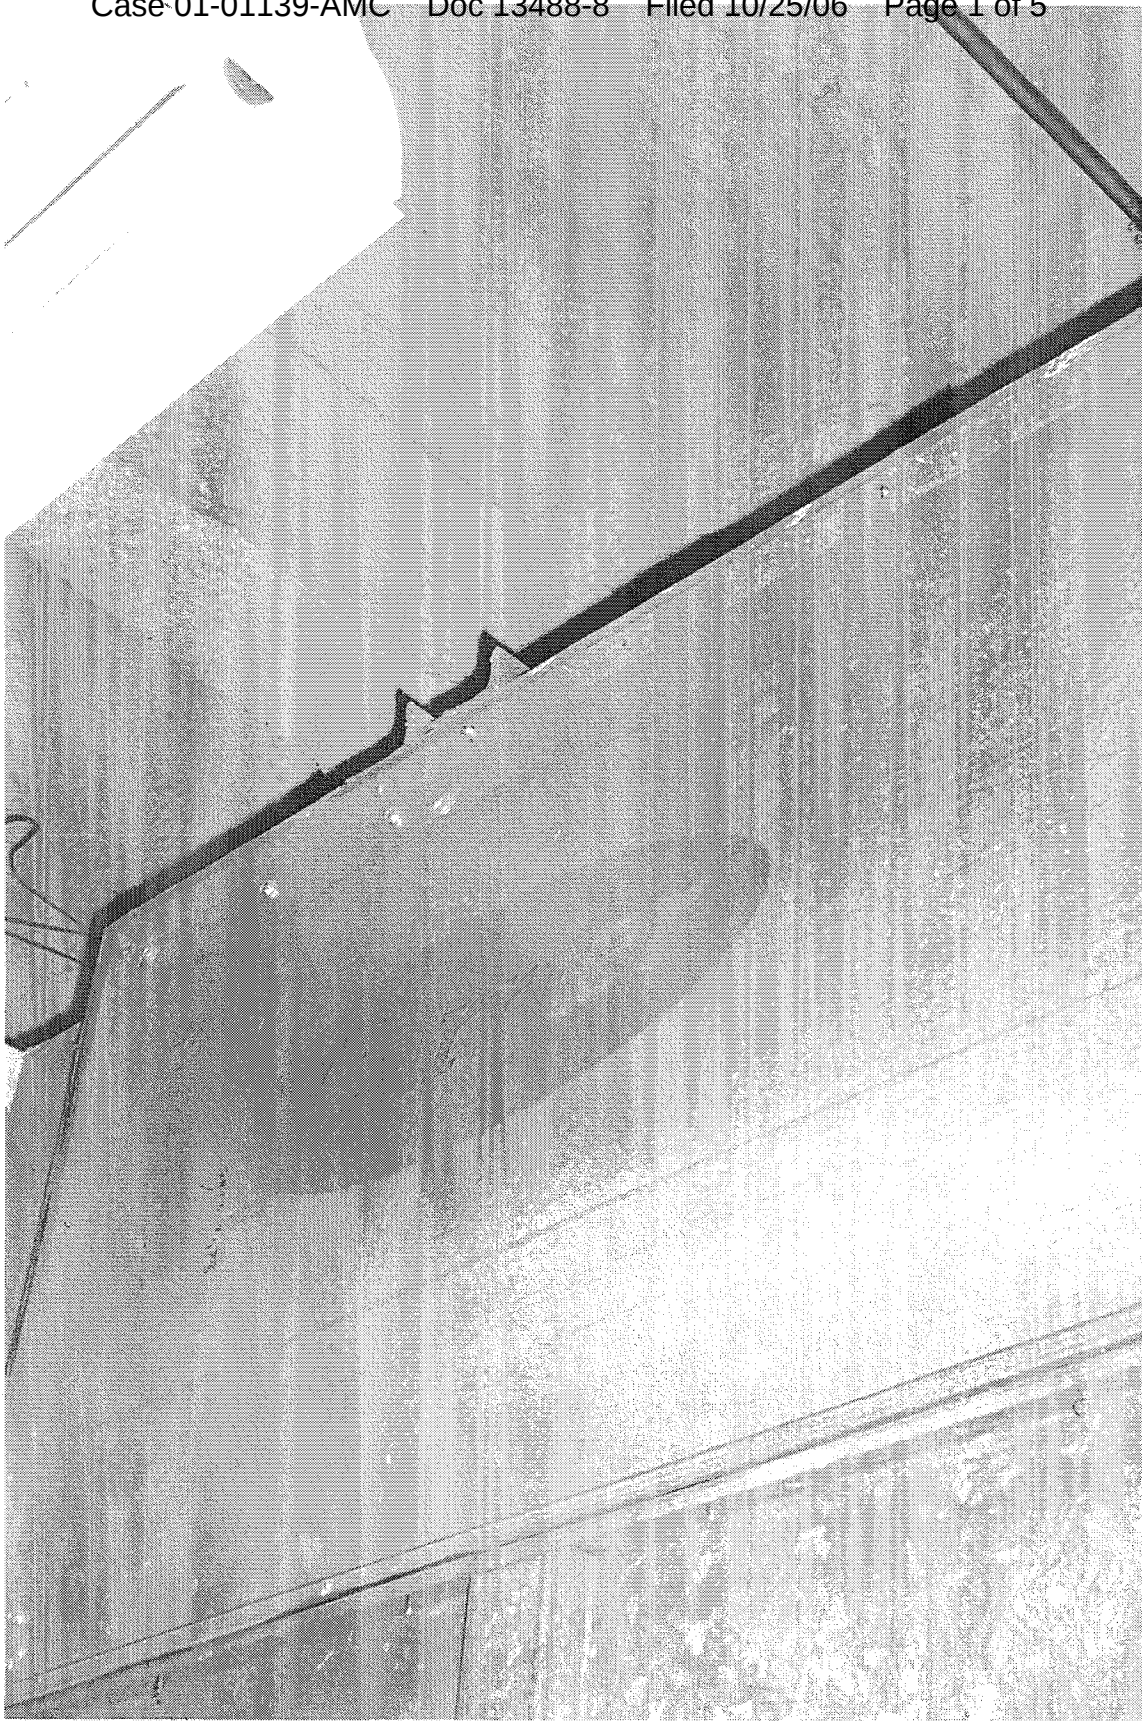
22. Main Terminal, 3rd floor, Air Handler Room - Exposed fireproofed decking above HVAC fan unit

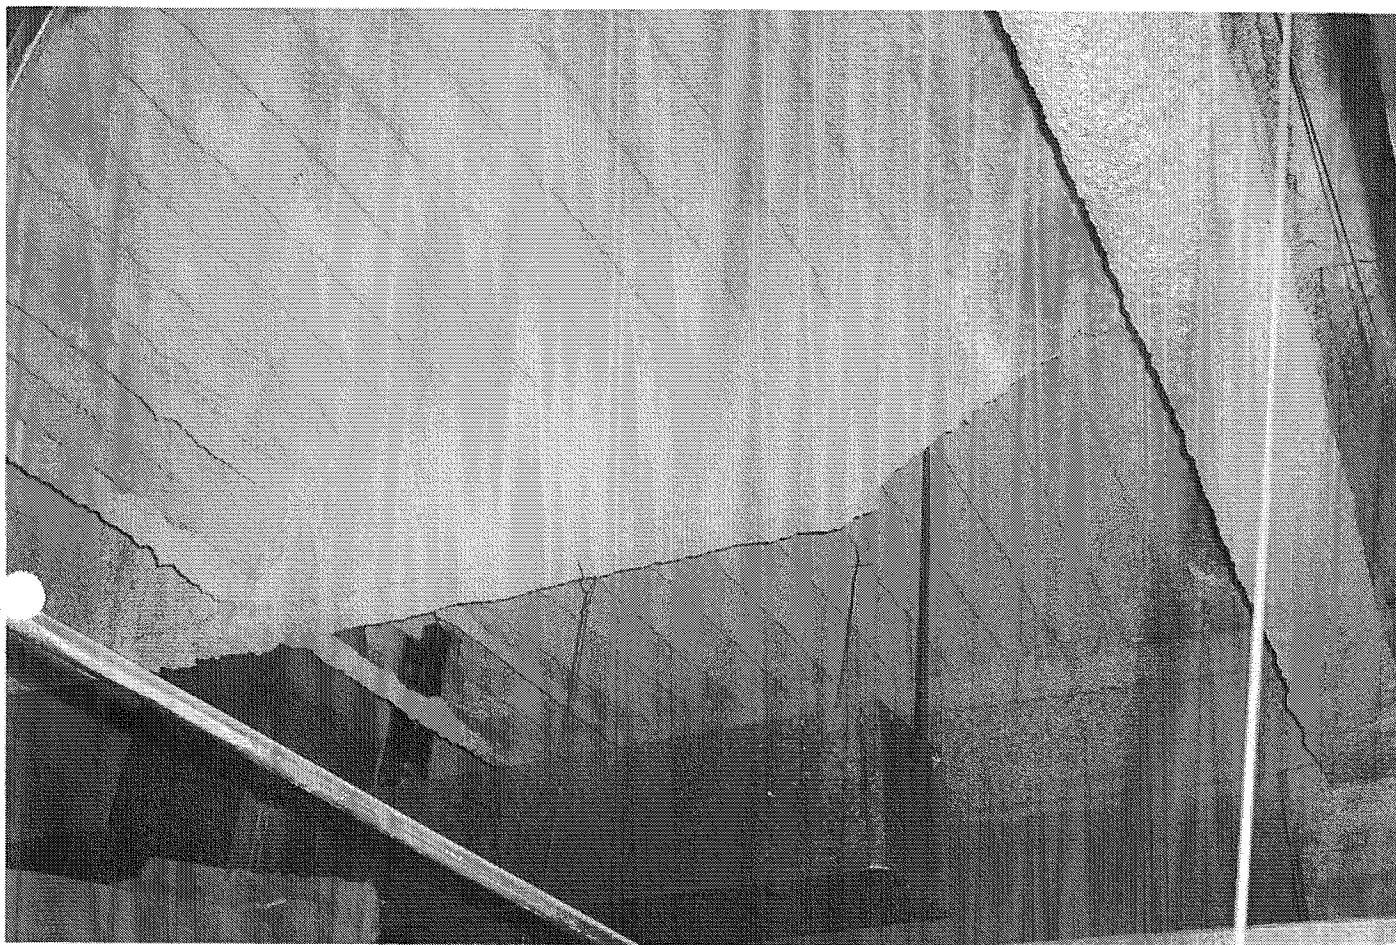
23. Main Terminal, 3rd floor, Mens Rest Room - General view of fireproofed metal decking and beams above suspended ceiling (note: water damage)

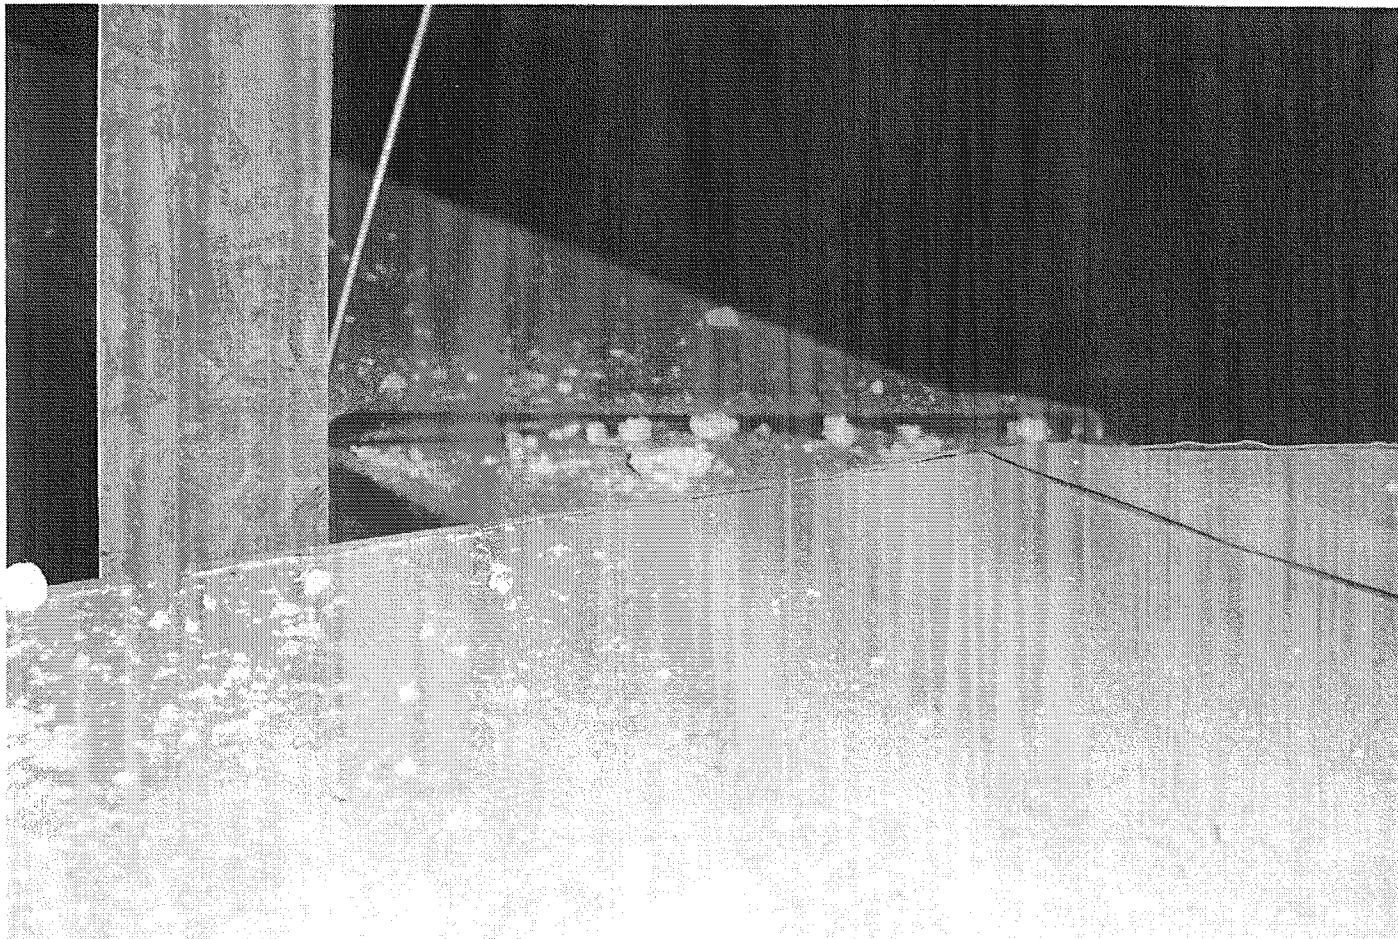
24. Main Terminal, 3rd floor, Mens Rest Room - View of delaminated fireproofing debris on top of metal HVAC duct

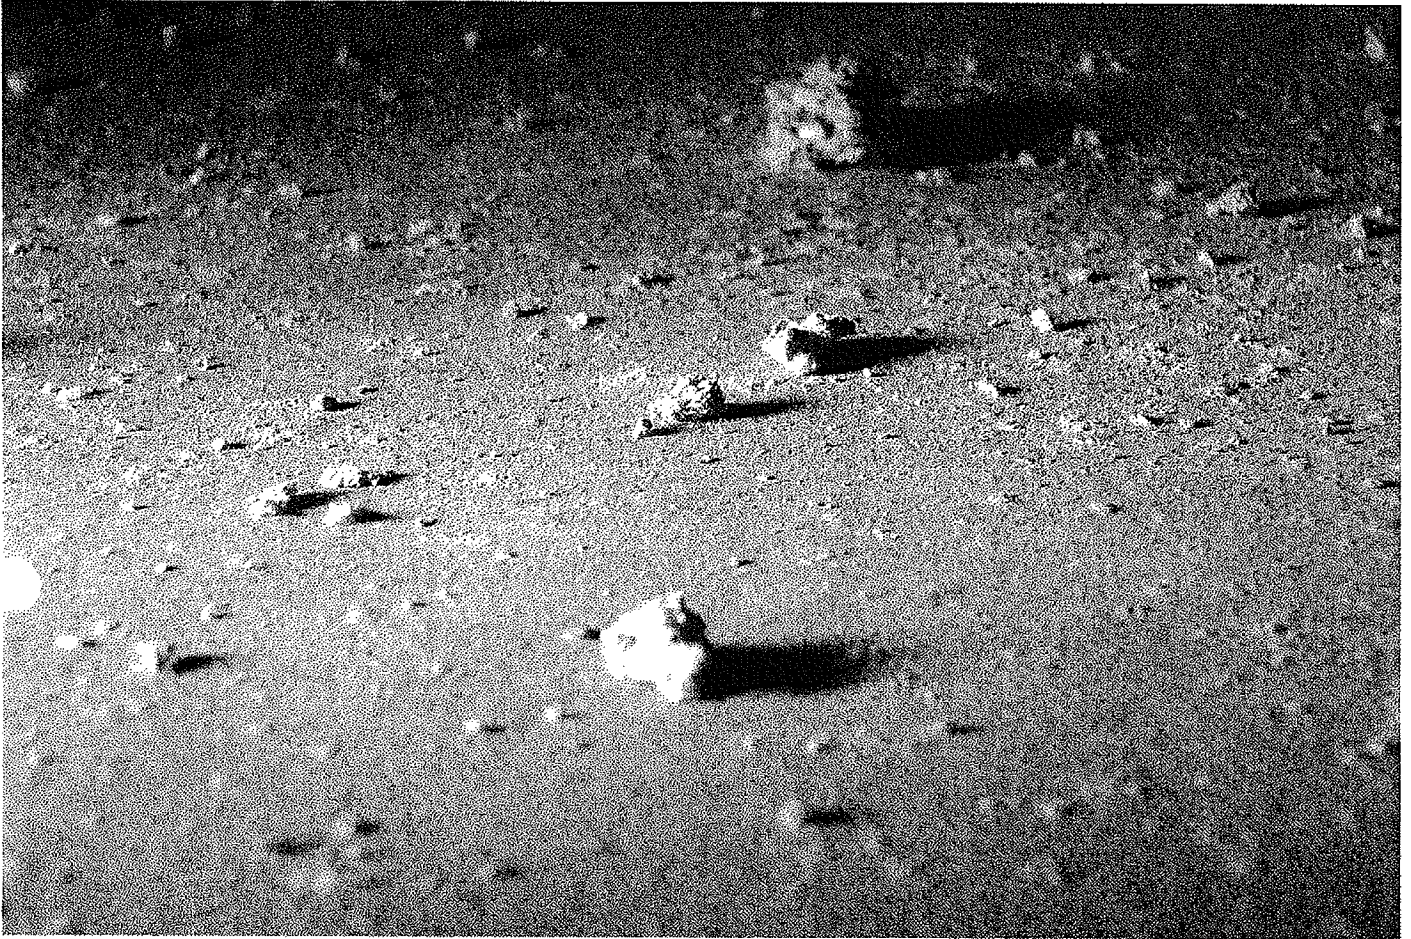
25. Main Terminal, 3rd floor, Mens Rest Room - Close-up of delaminated fireproofing dust and debris on top of metal HVAC duct

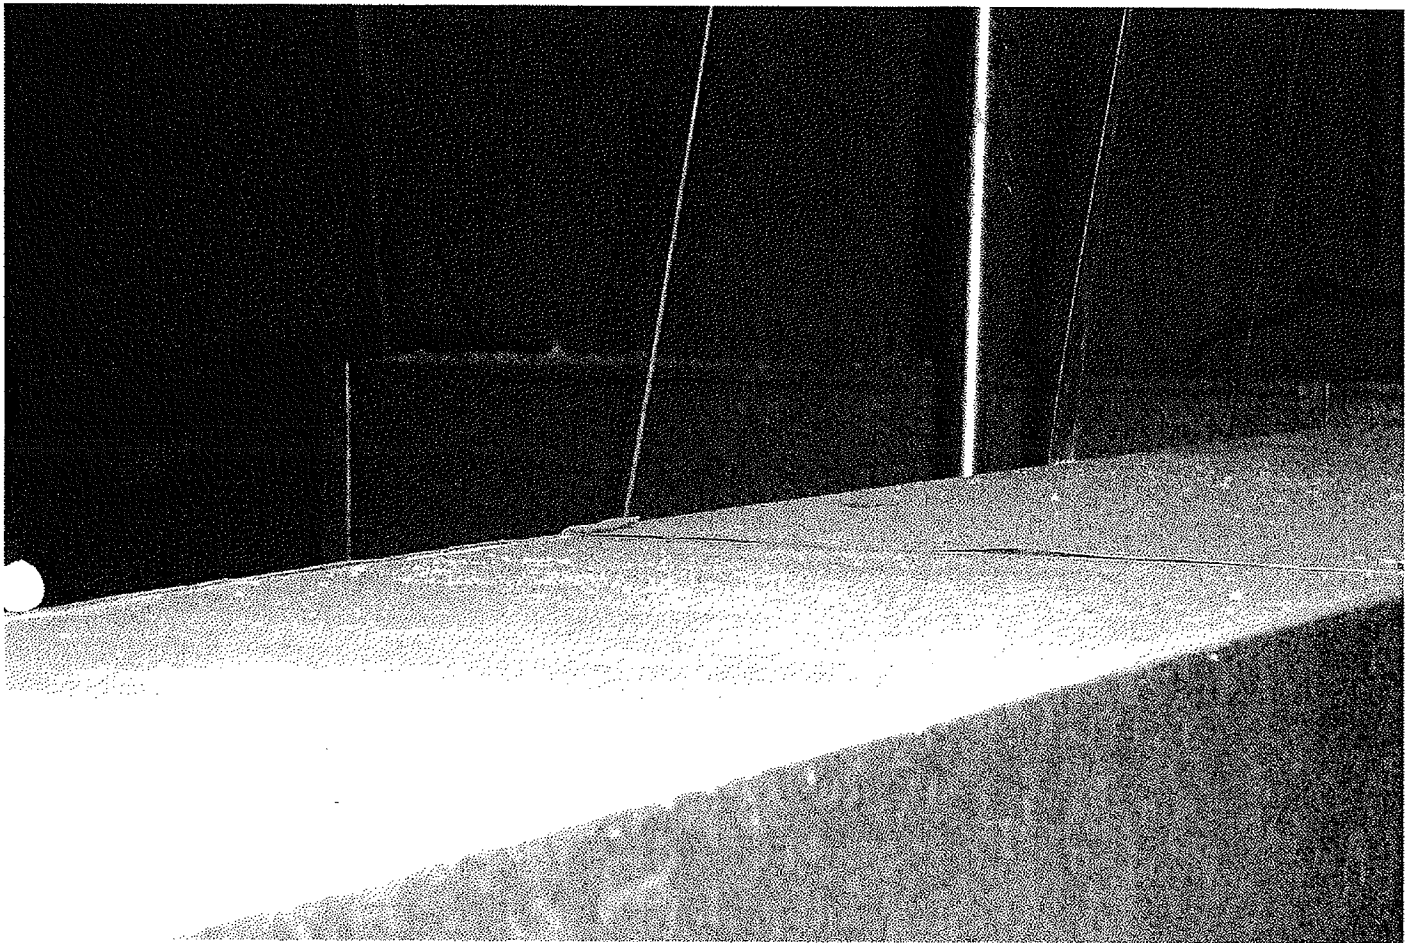
26. Main Terminal, 3rd floor, Mens Rest Room - View of delaminated fireproofing dust and debris on top of metal HVAC duct
